EFFECTS OF THE LOMA PRIETA EARTHQUAKE  
ON THE MARINA DISTRICT  
SAN FRANCISCO, CALIFORNIA

OPEN-FILE REPORT 90-253

Menlo Park, California

April 20, 1990

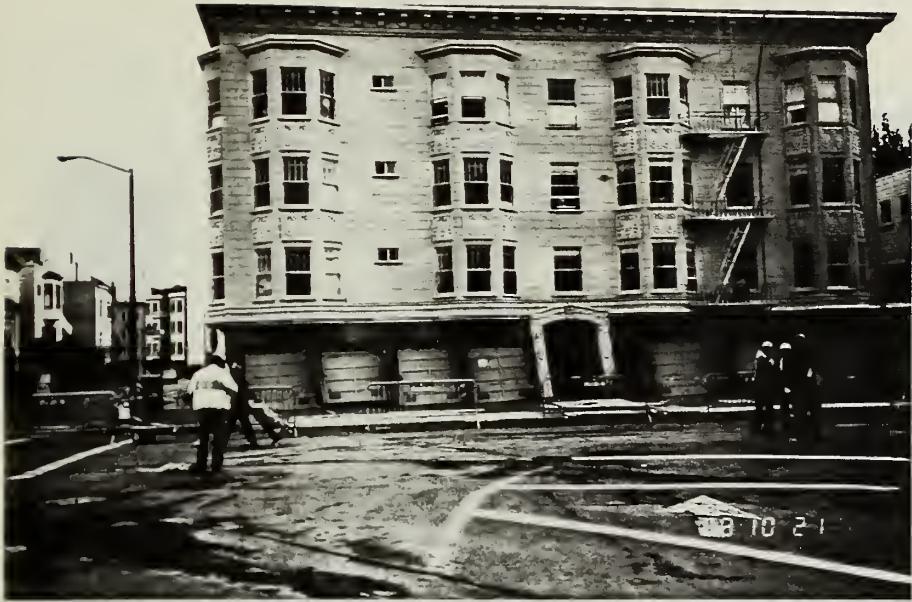
Figure 1

- Figure 1. This building, like many others in the Marina District, was at the corner of the block and had a soft first story. The upper floors are stiffer than the first floor.
- Figure 2. (a) The building was built on land where an 8' sewer pipe crossed. During the earthquake, differential settlement in the vicinity of the pipe adversely affected the building. (b) the differential settlement of the pipe caused a 1"/foot slope on the sidewalk and consequently considerable damage to the building.
- Figure 3. The timber in many buildings was deteriorated as in this one.
- Figure 4. (a) Some buildings were not at all or insufficiently bolted to the foundation. This building on Jefferson Street of the Marina District suffered from both the pounding effect from the adjacent buildings; and (b) the lack of sufficient anchorage of the building to the foundation.

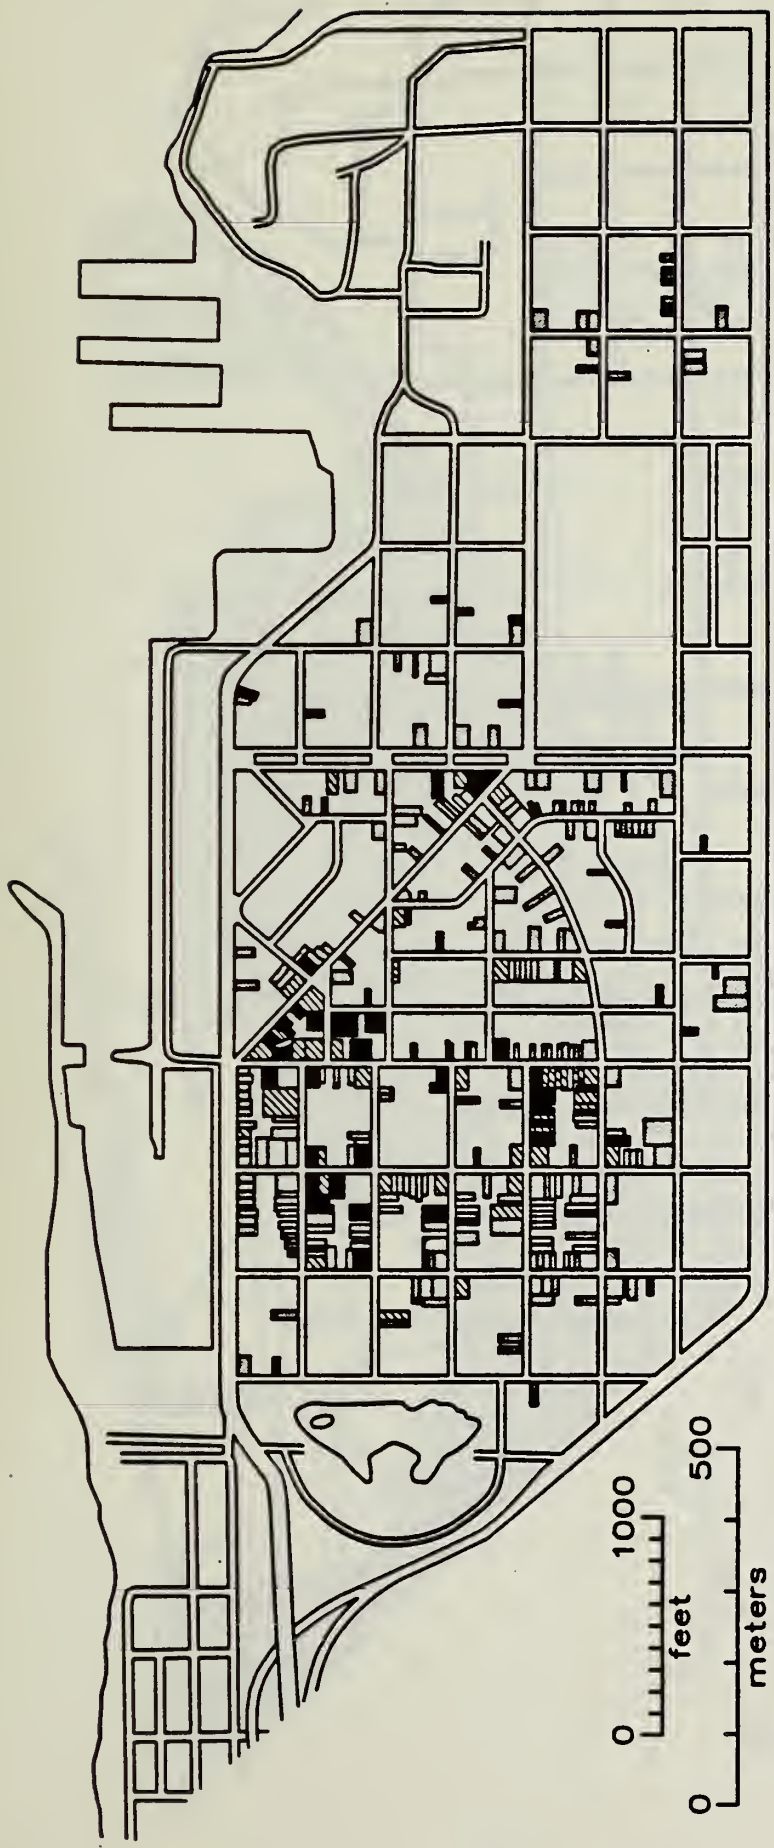
Figure 1. Buildings in the Marina District with red or yellow tags from the City of San Francisco Building Department following the October 17, 1989 Loma Prieta earthquake.

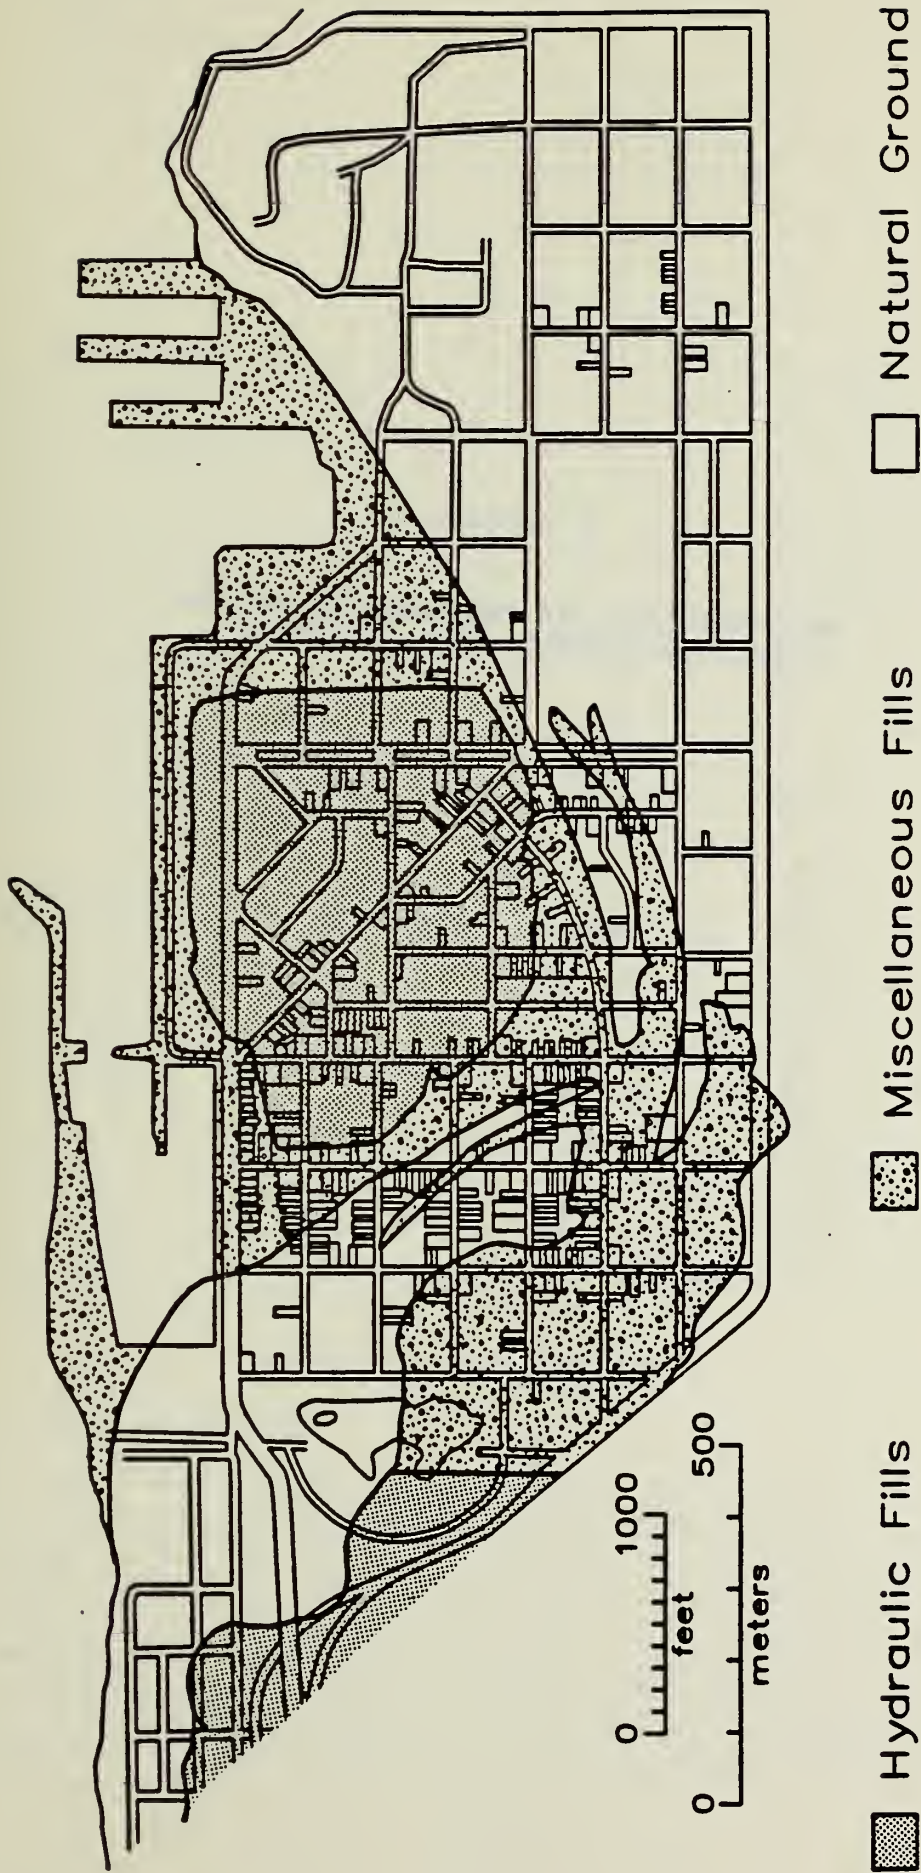
Figure 2. Ground type and red and yellow tagged structures in the Marina District.

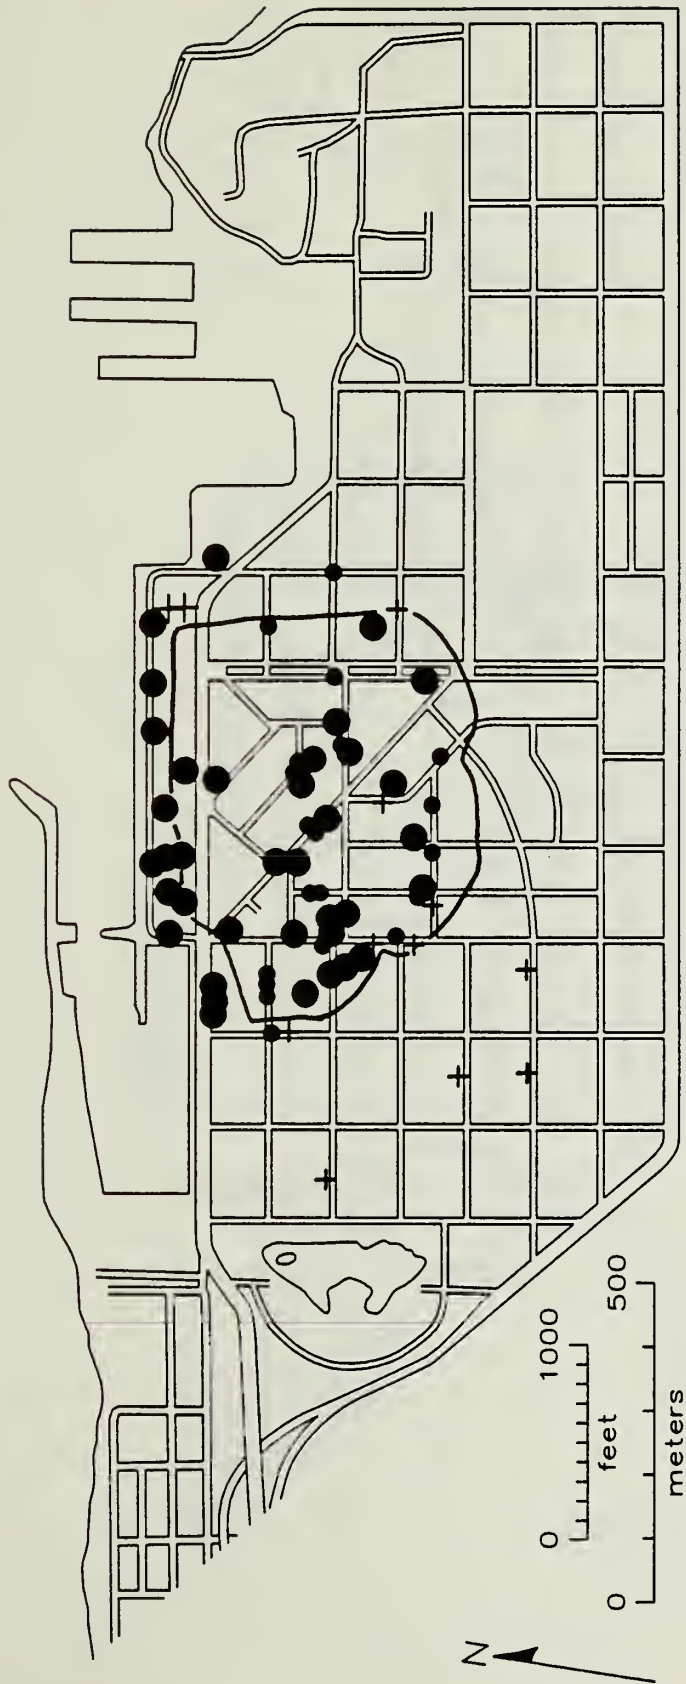
Figure 6. Location of sand boils. Sand boils are found primarily in the area

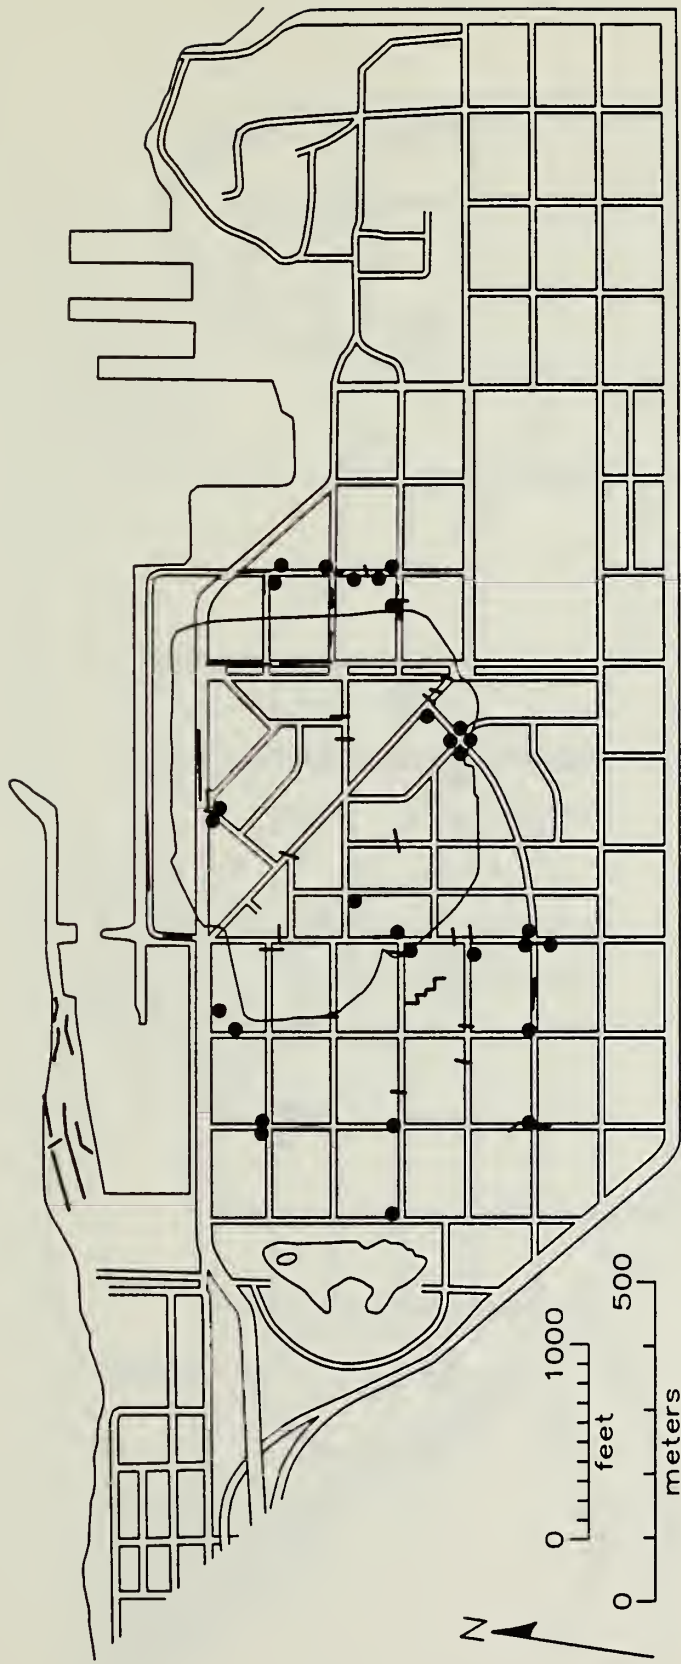
Figure 7. Distribution of cracks and curb damage.

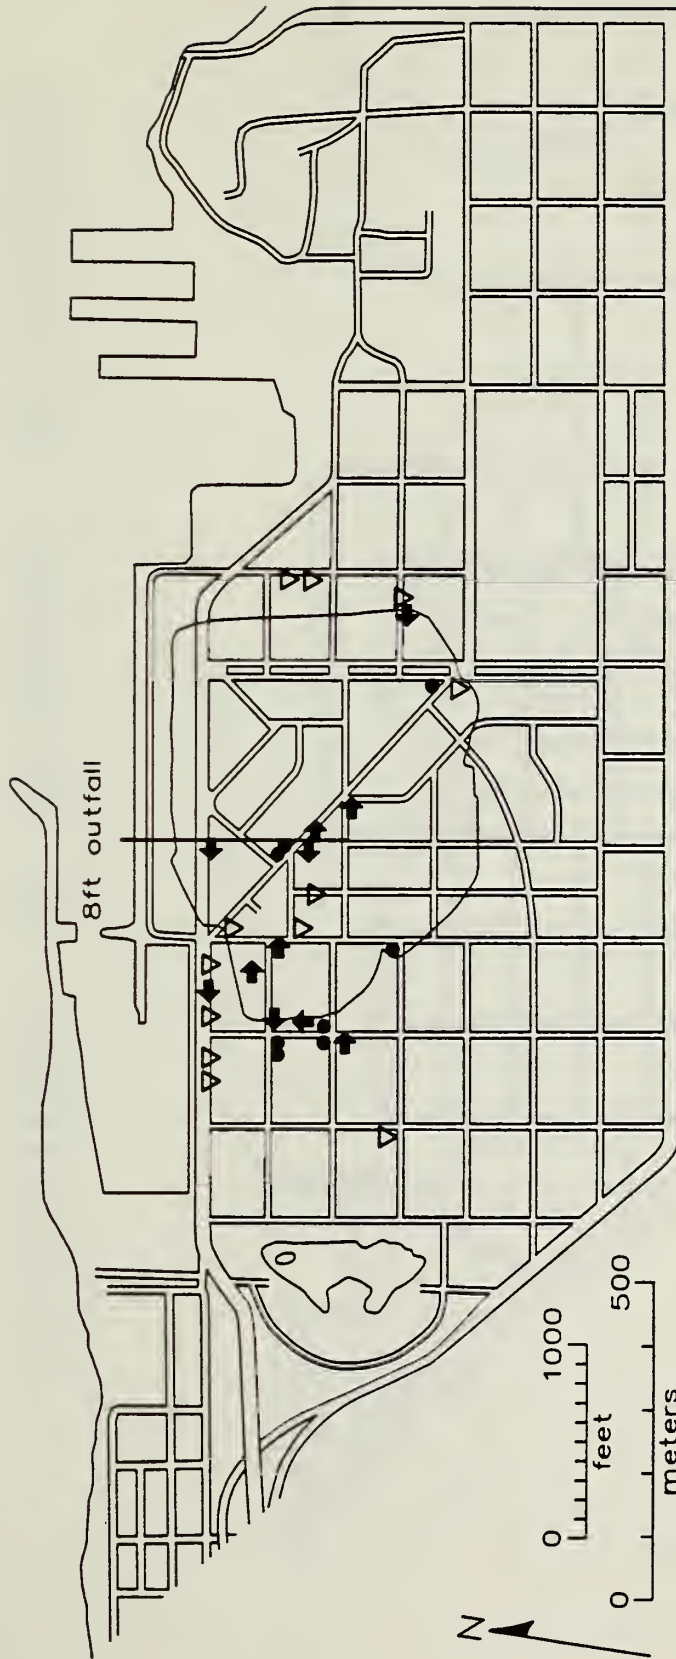
Figure 8. Buildings that were demolished, badly tilted, or displaying large settlements are generally confined to the areas that were filled.

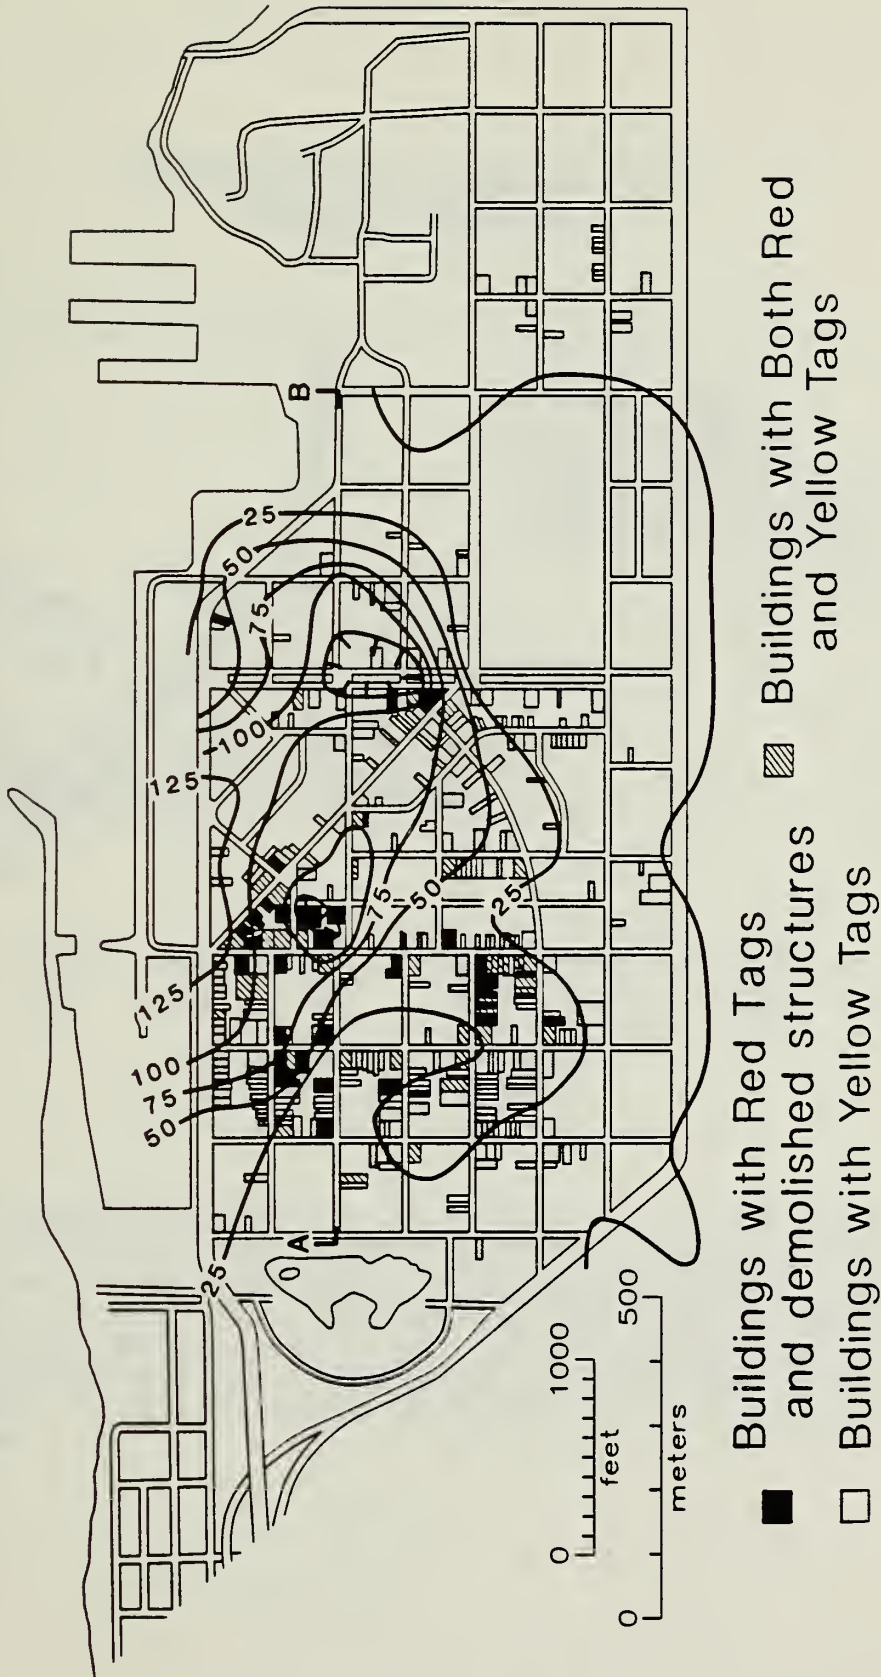
Figure 16. Red and yellow tag damage map (Seekins, this volume) is superimposed with 1974-1989 settlement contours. No points were surveyed east of Laguna or west of Baker.

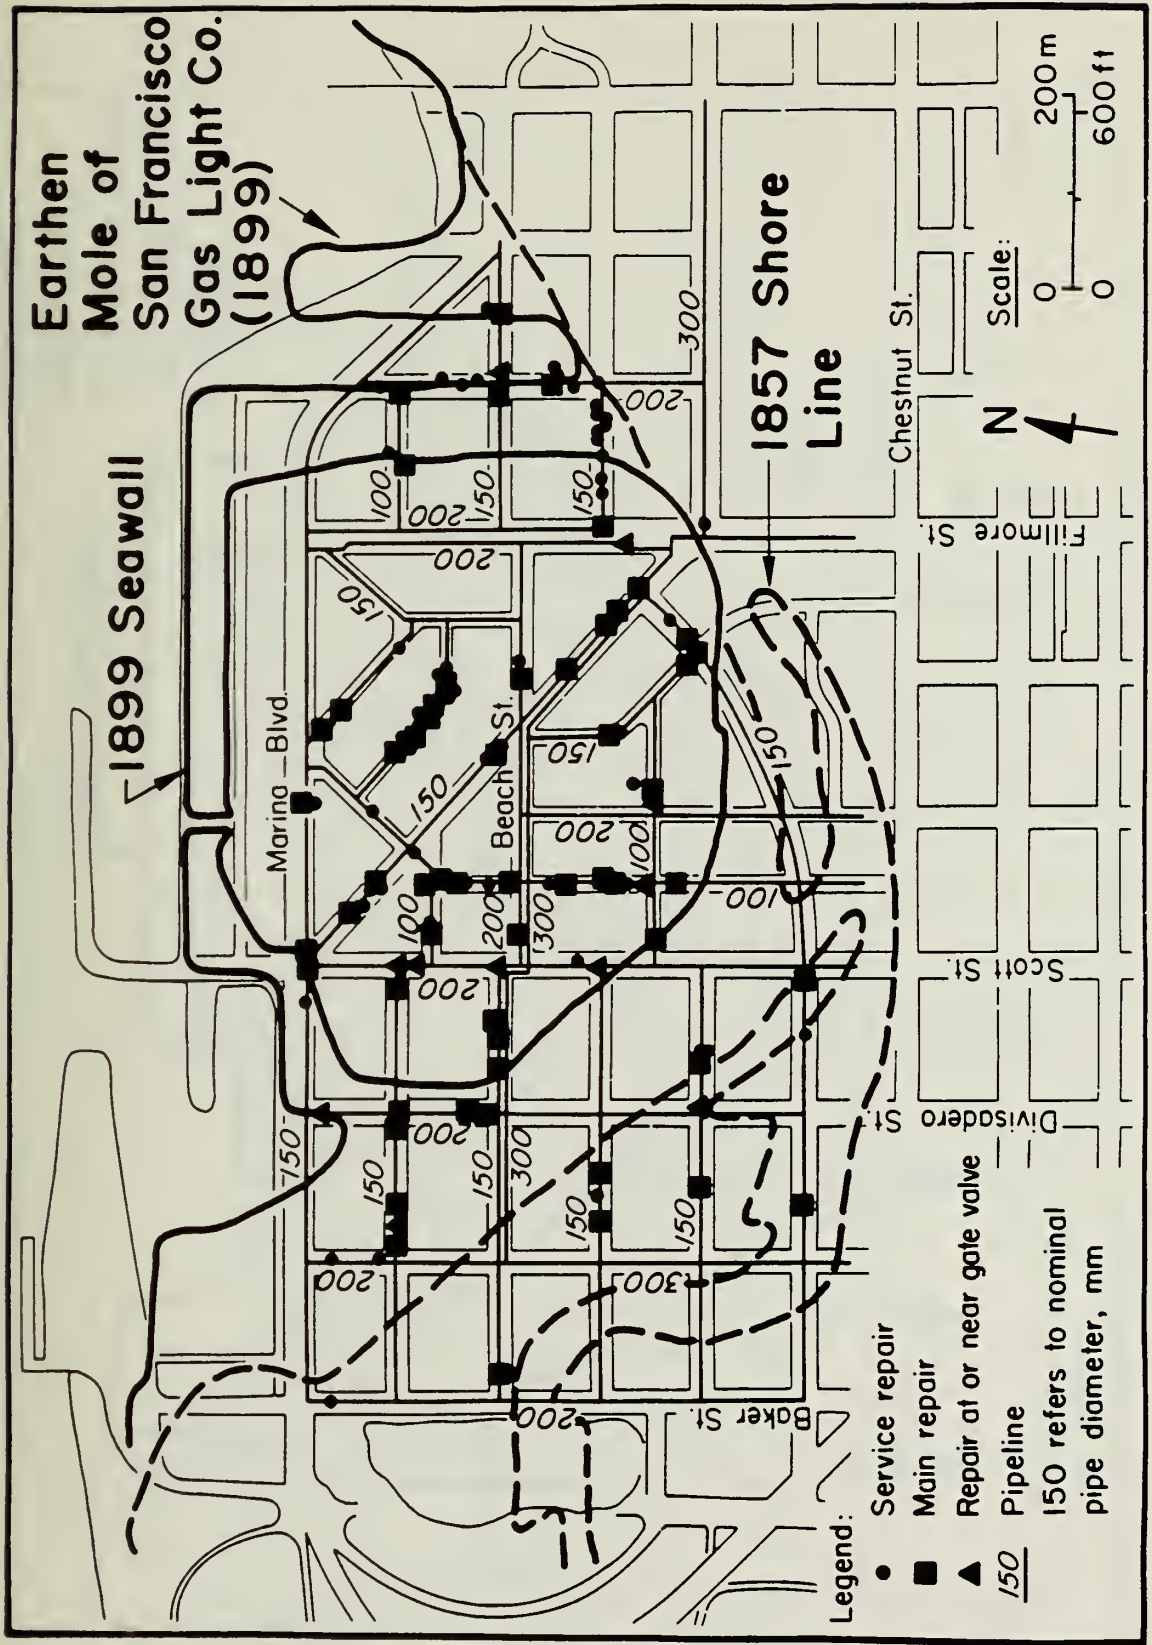
Figure 1. Map view of repairs to Municipal Water Supply System in the Marina District.

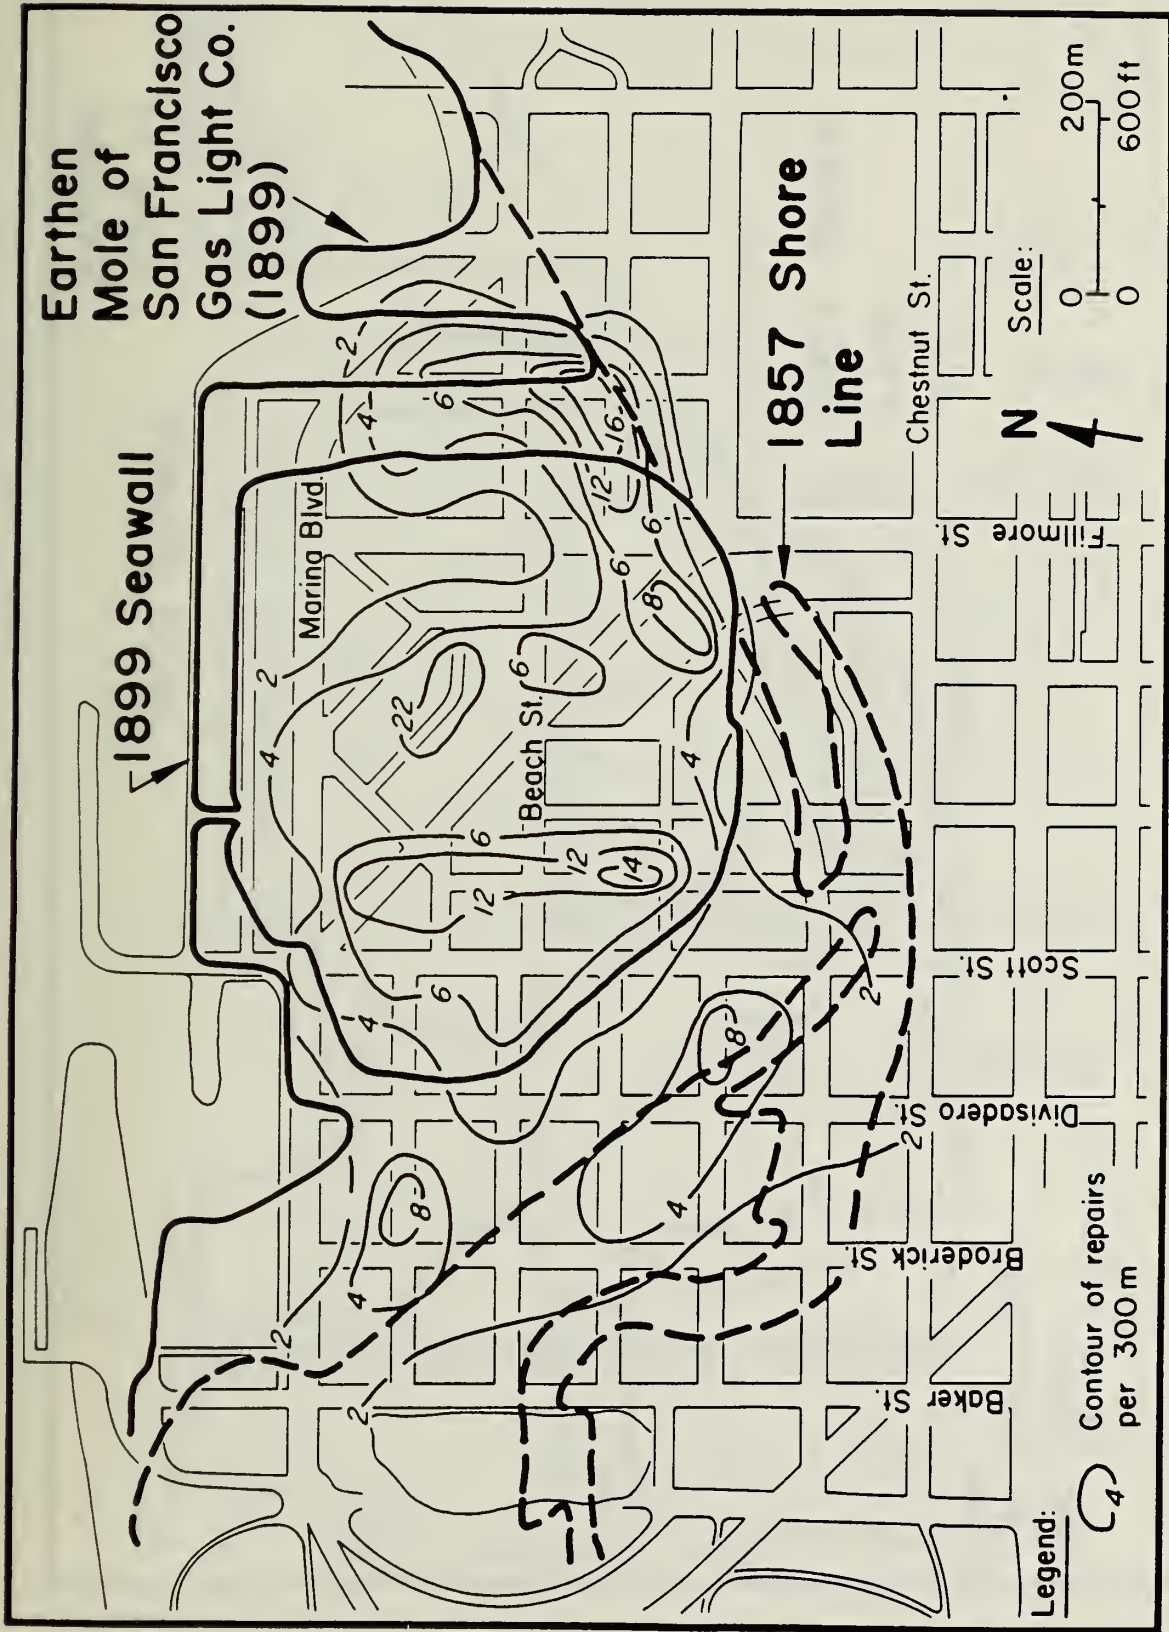
Figure 2. Contours of repairs to the Municipal Water Supply System per 300 m of pipeline.

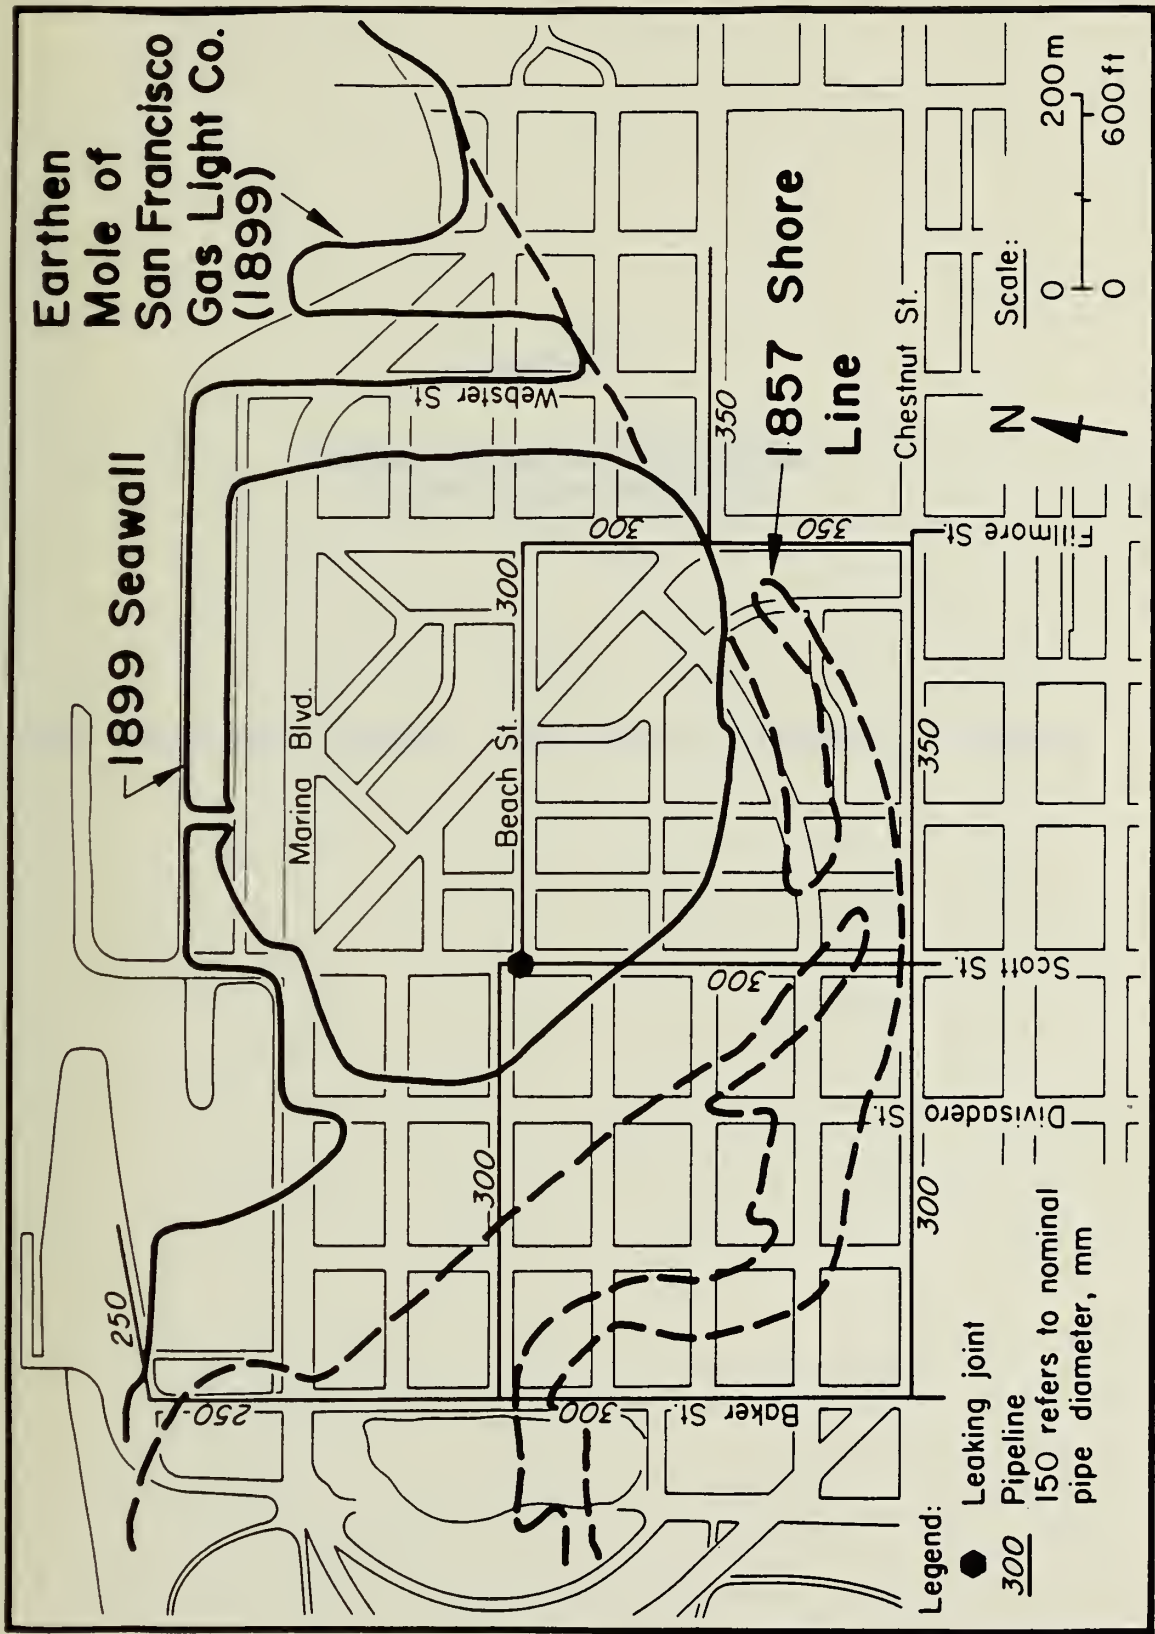
Figure 3. Map view of repairs to Auxiliary Water Supply System in the Marina District.
